Rimkus Consulting Group, Inc.
Eight Greenway Plaza, Suite 500
Houston, TX 77046
(800) 580-3228 Telephone
(713) 623-4357 Facsimile

Re: RCG File No: 11009971
LLV Number: 0209452
VMF Location: 1530 Greensmark Drive in Houston, Texas
Subject: Final Report

Rimkus Consulting Group, Inc. was retained to examine LLV 0209452, VIN 1GBCS10E4M2908832. The fire occurred on June 13, 2016 at around 12:30 P.M. the operator of the vehicle at the time of the fire, was unavailable for interview but reportedly stated the vehicle's engine died while delivering mail on his route and backfired during subsequent attempts to restart it. Soon thereafter, smoke was observed from beneath the hood as well as flames.

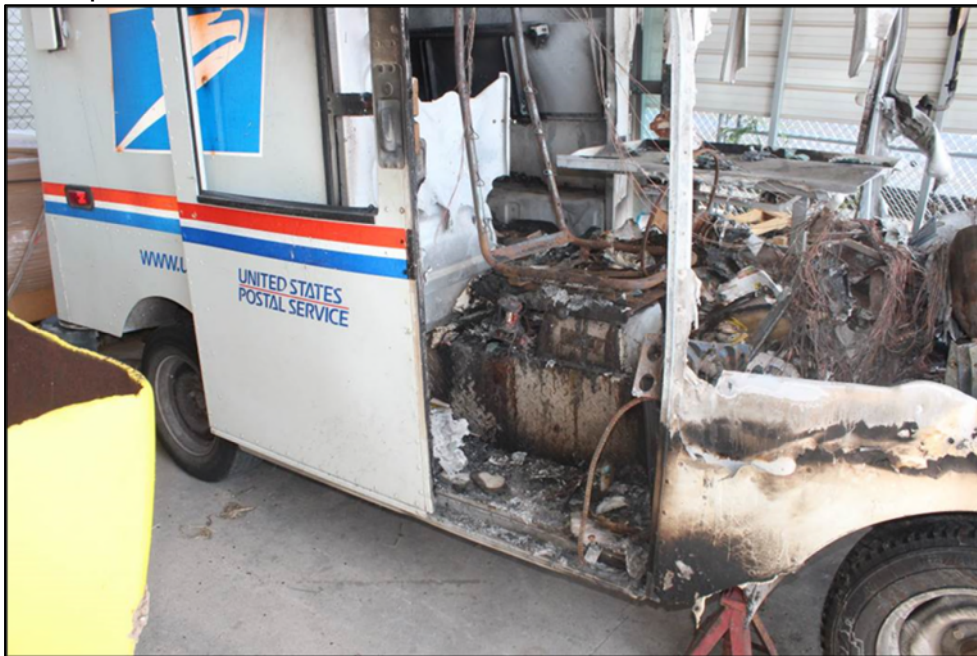
Photograph 2

A view of the interior of the vehicle, observe the progression of the burn patterns from the engine compartment.

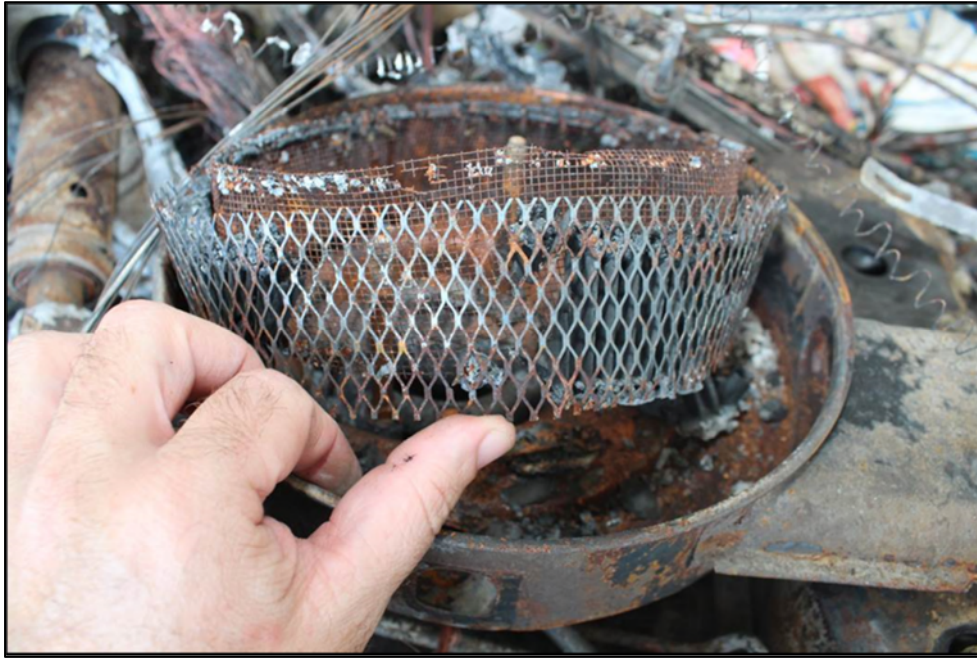
Photograph 3

View of air filter remains and air cleaner housing.

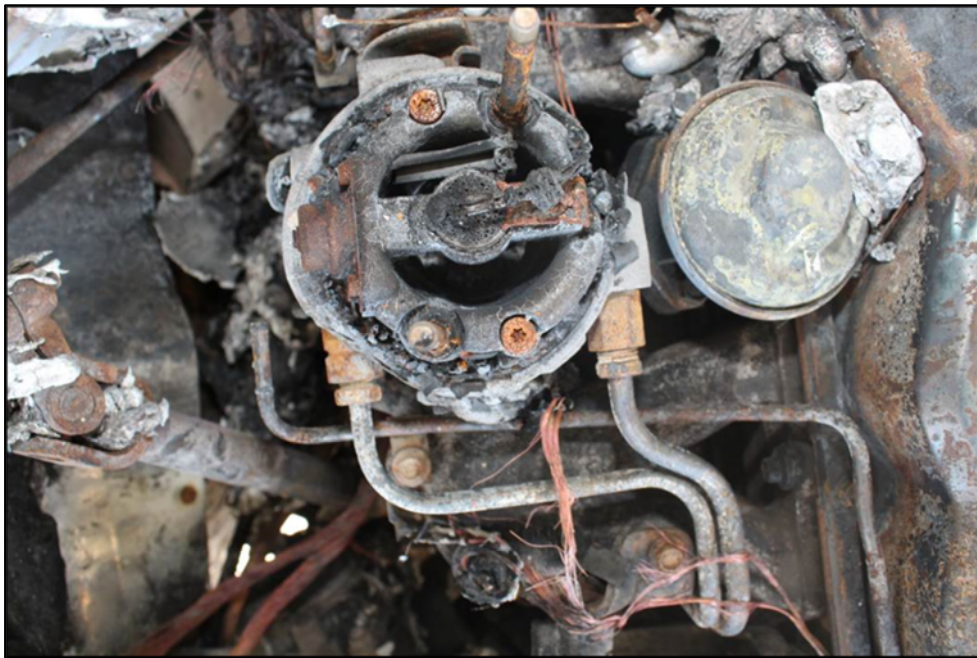
Photograph 4

A view of the area of fire origin at and within the carburetor/air cleaner assemblies.

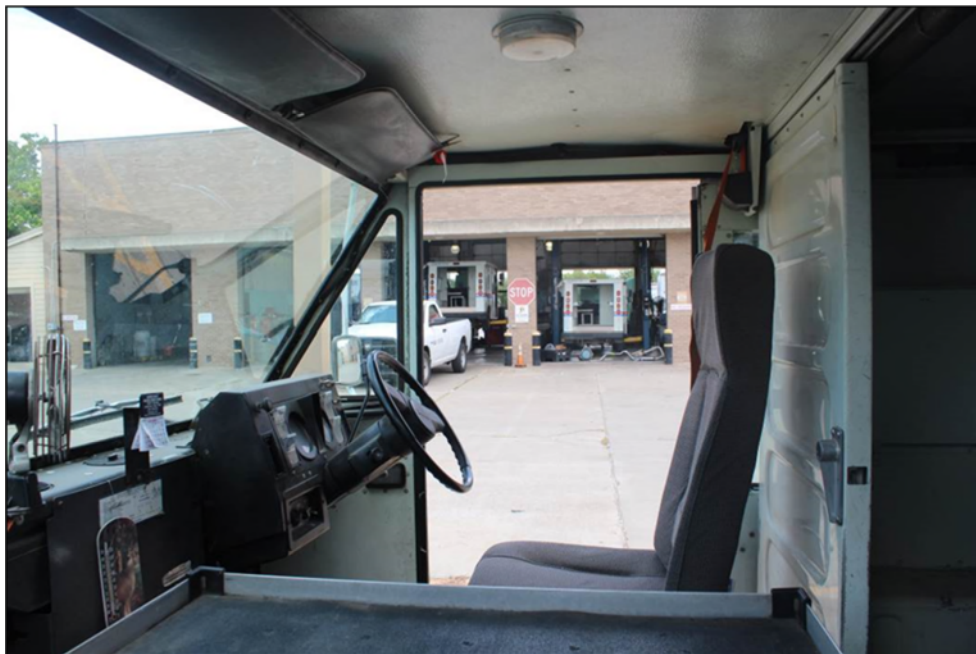
Photograph 2

Interior view of passenger/operator compartment (no visible fire exposure inward).

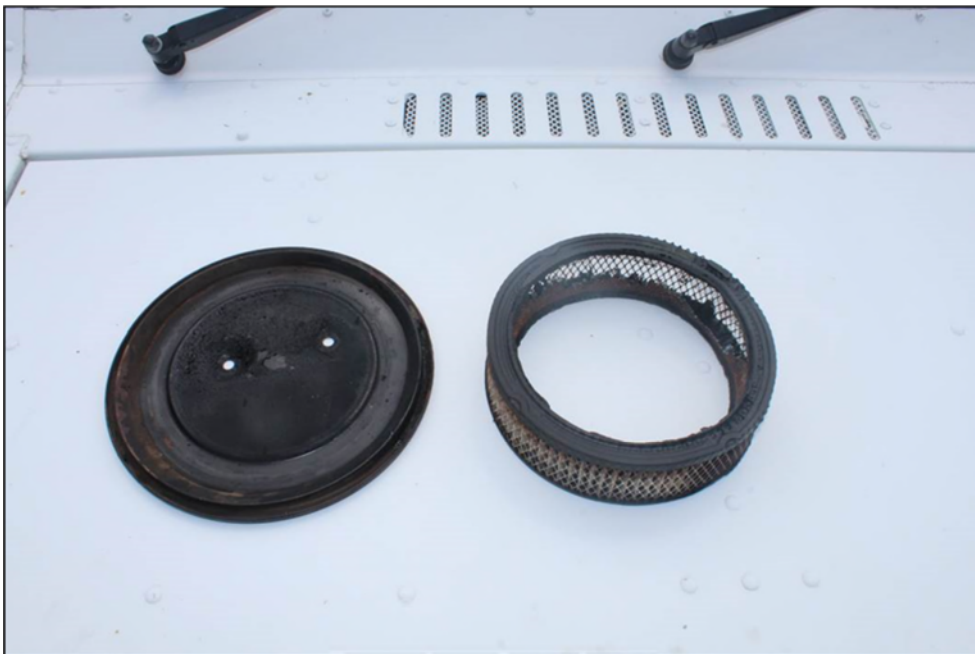
Photograph 4

Detailed view of area of origin components (air filter and filter cover).

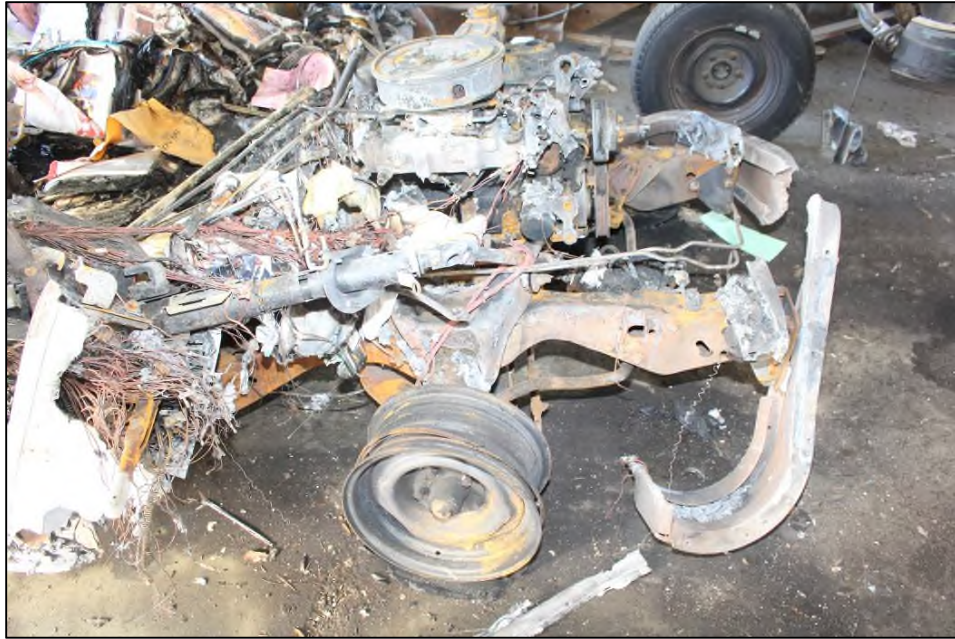
Photograph 5

The fire damaged engine compartment.

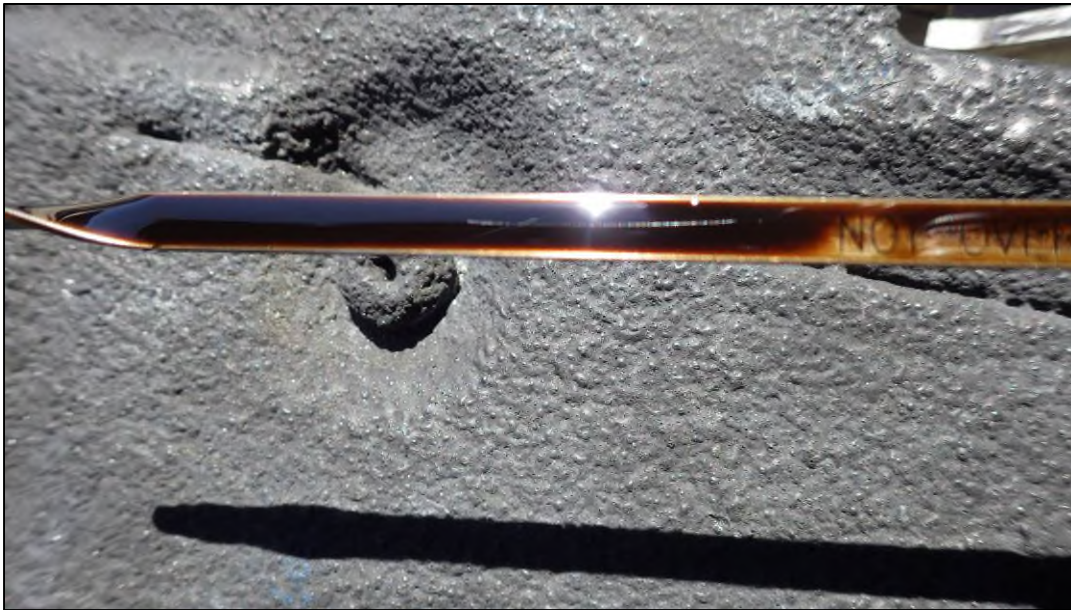
Photograph 7

Oil level on the dipstick. Notice that the oil is past the maximum fill line and actually covers the word "DO" where it states "DO NOT OVERFILL".

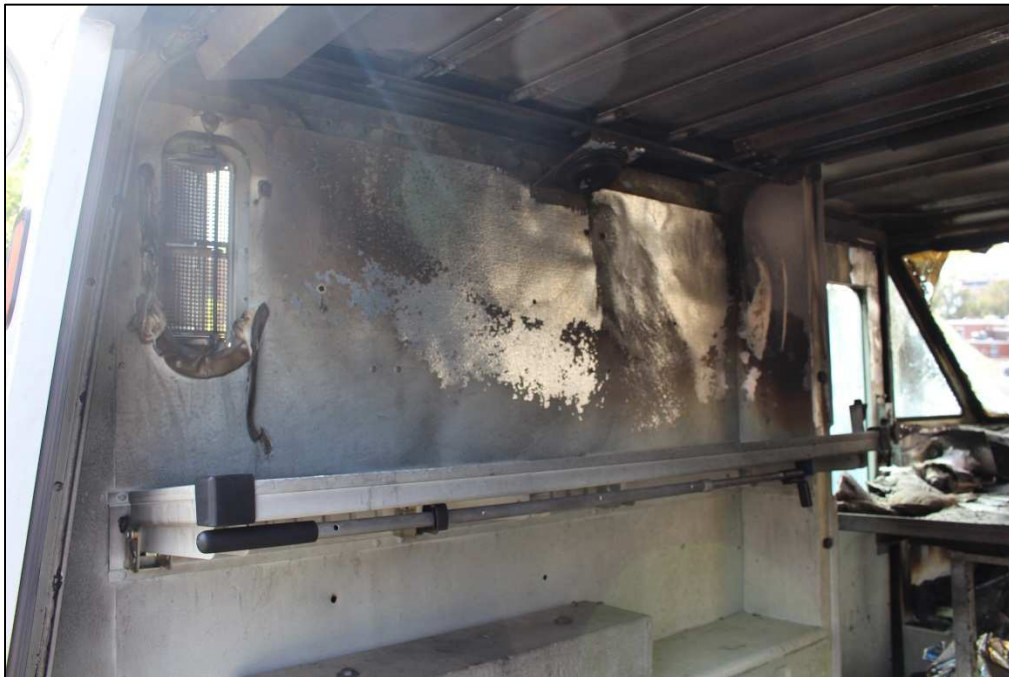
Photograph 8
Movement Fire pattern indicating a fire originating in the front of the vehicle.

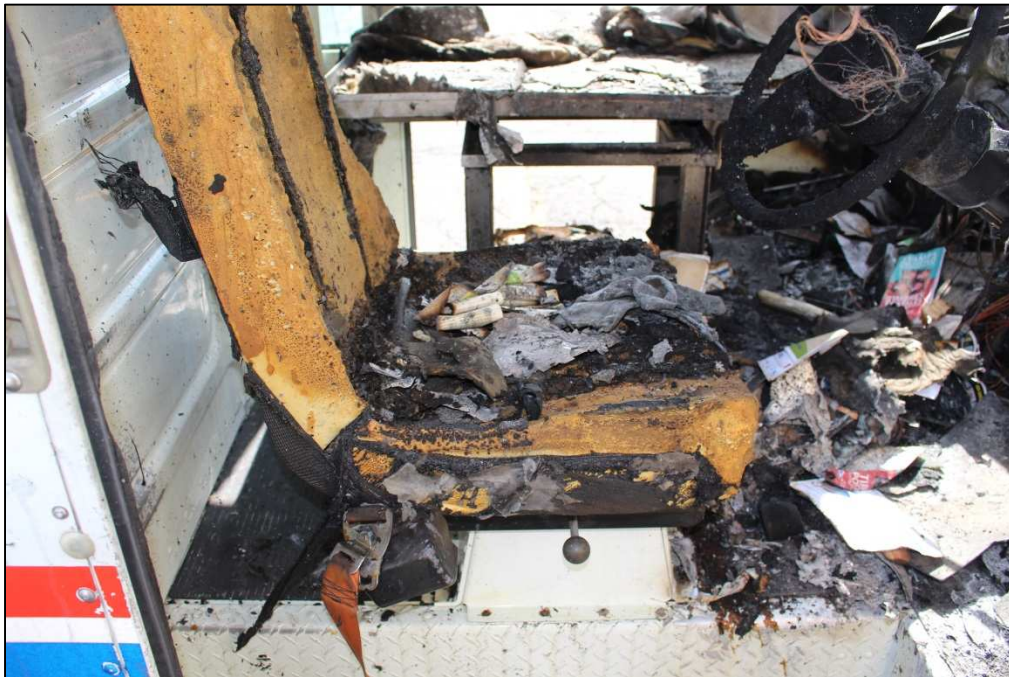
Photograph 10
Drivers area.

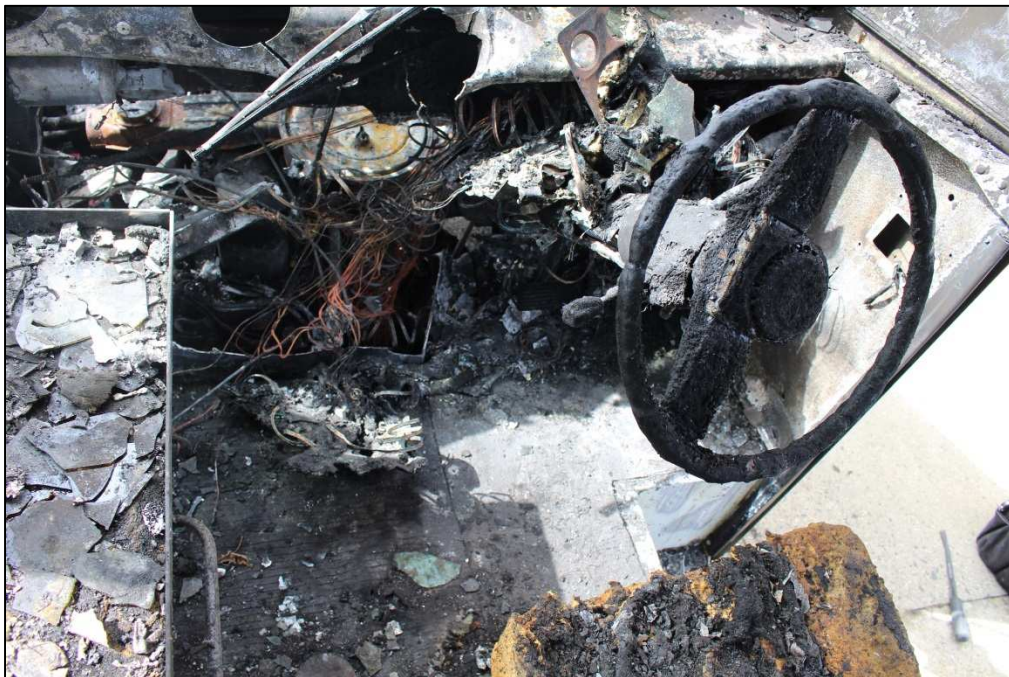
Photograph 12
Interior of LLV after delayering of the fire debris.

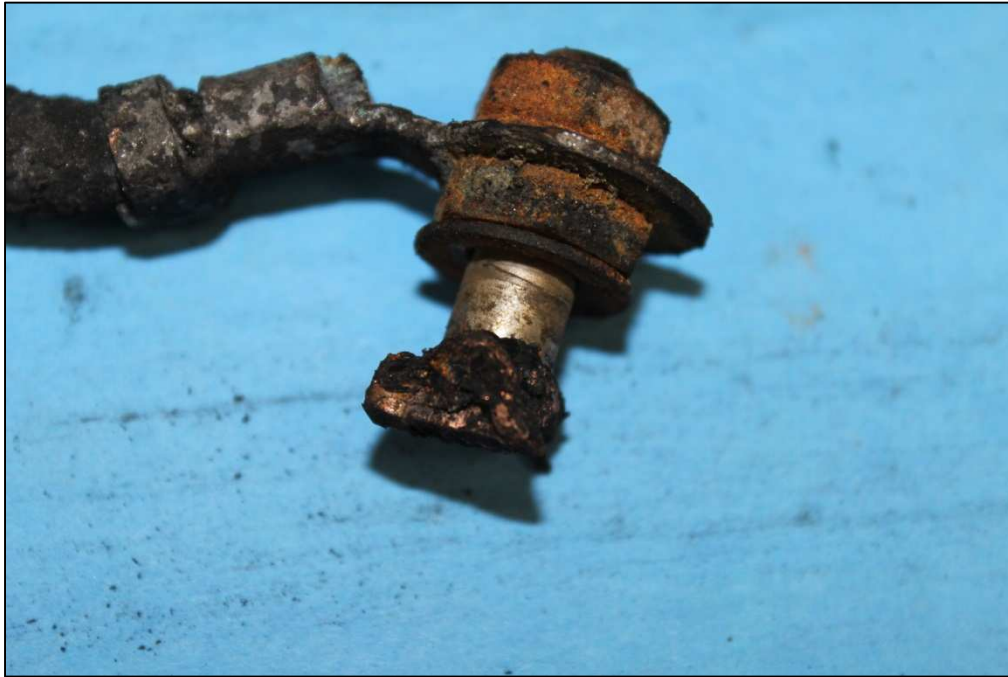
Photograph 21

Electrical connection point of starter still attached to power cable.

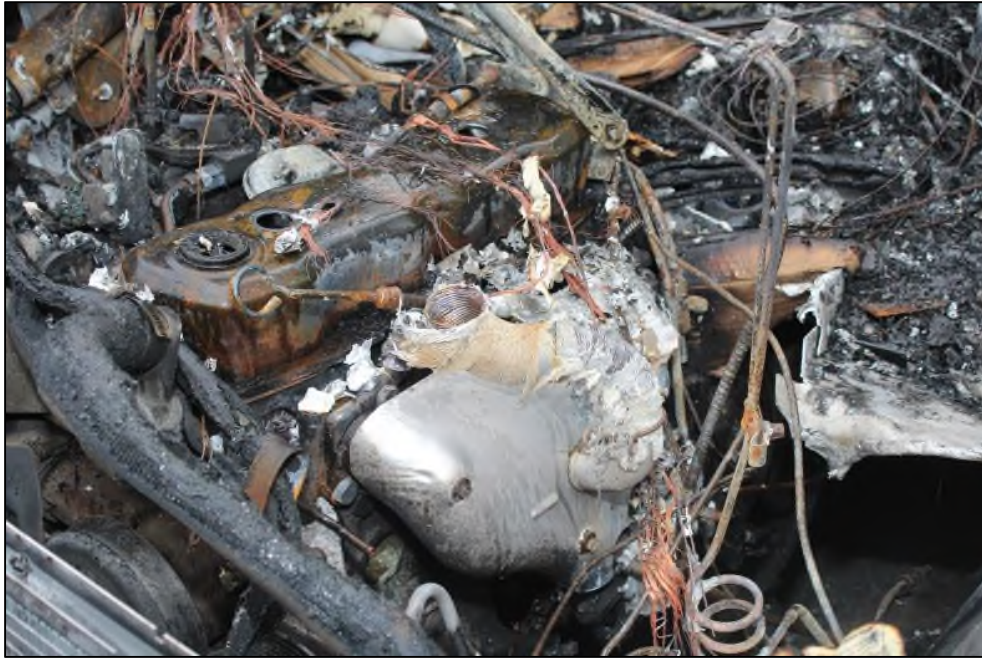
Photograph 7

engine crank shaft and appeared to have been blown from the inside out by a piston rod failure. A large quantity of oil was observed on the back side of the exhaust manifold. Based on the fire patterns observed, the left side of the engine within the engine compartment was determined to be the area of origin.

Exhaust manifold located on the left side of the engine block.

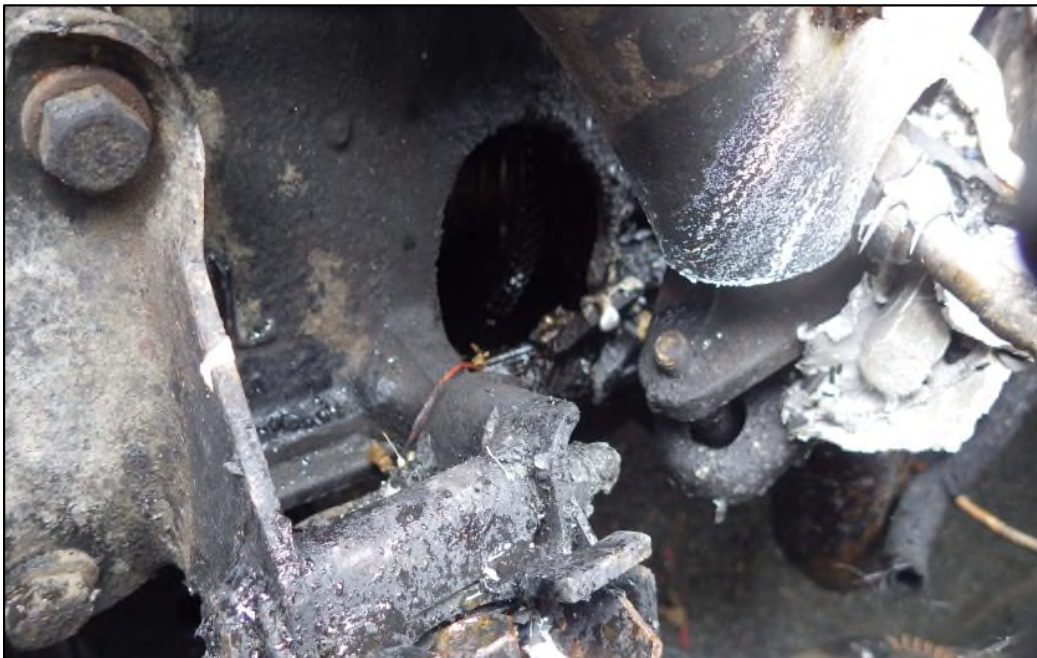
Photograph 8

Hole in the engine block behind the exhaust manifold.

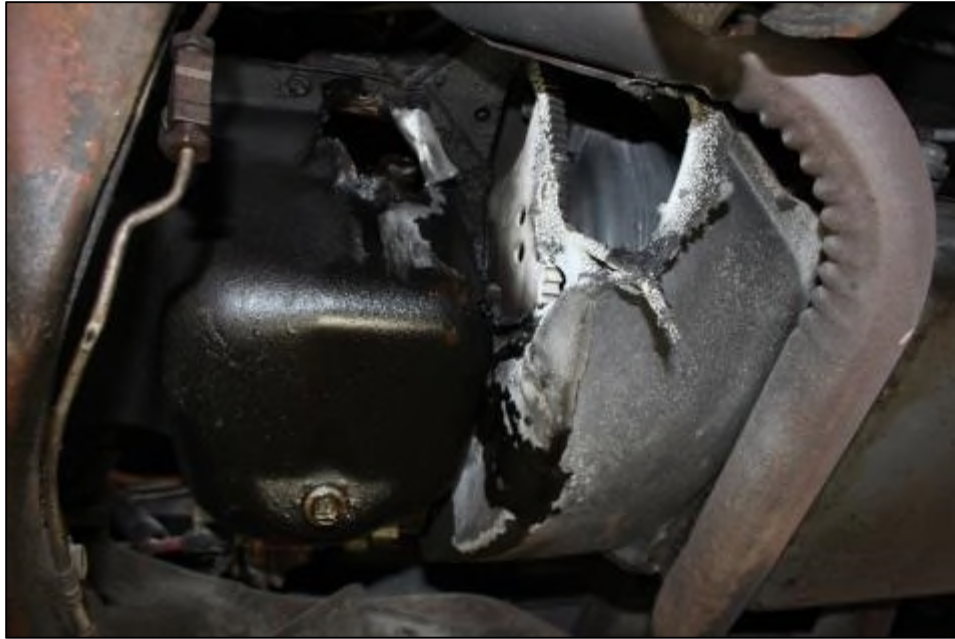
Photograph 9
Hole in crank case.

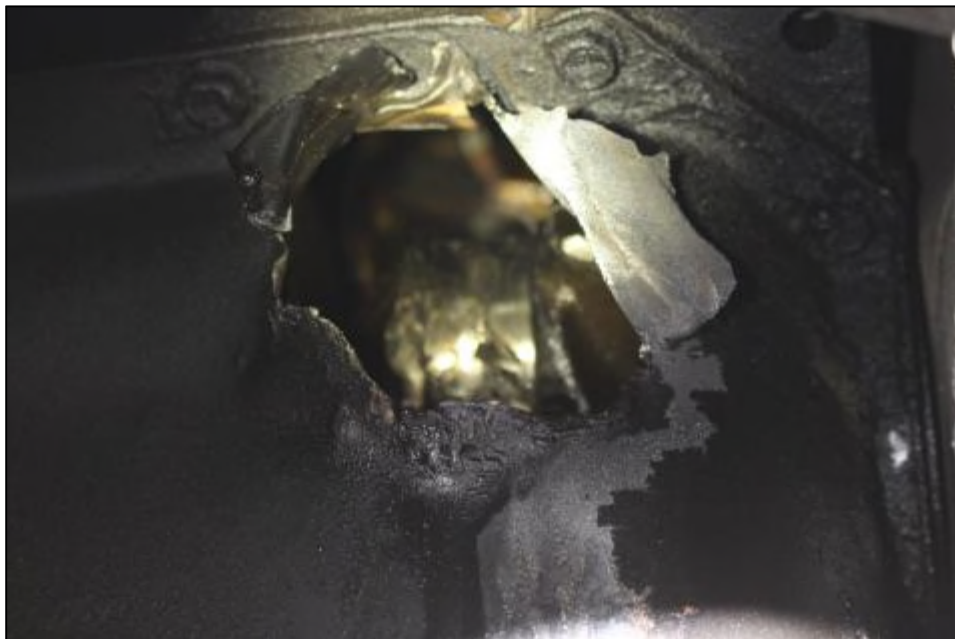
Photograph 10
Hole from crank shaft failure.

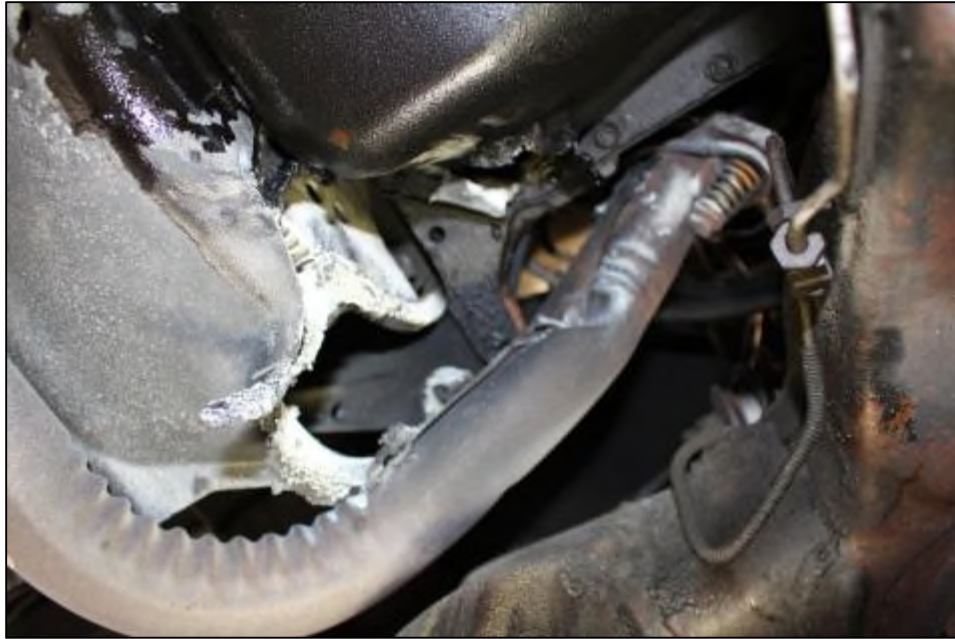
Photograph 11
Area of origin.

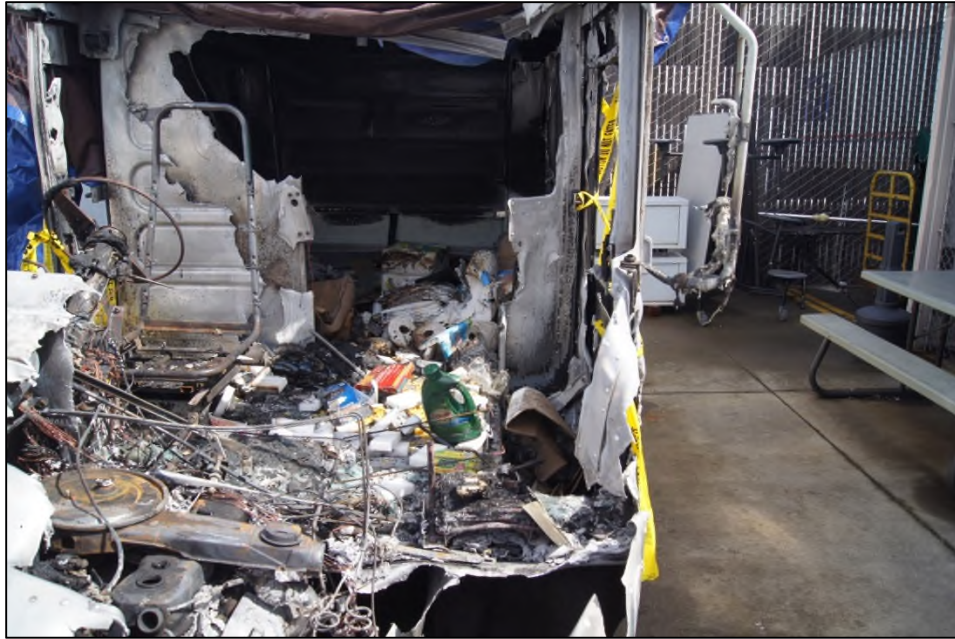
Photograph 1

Front of LLV showing fire progression.

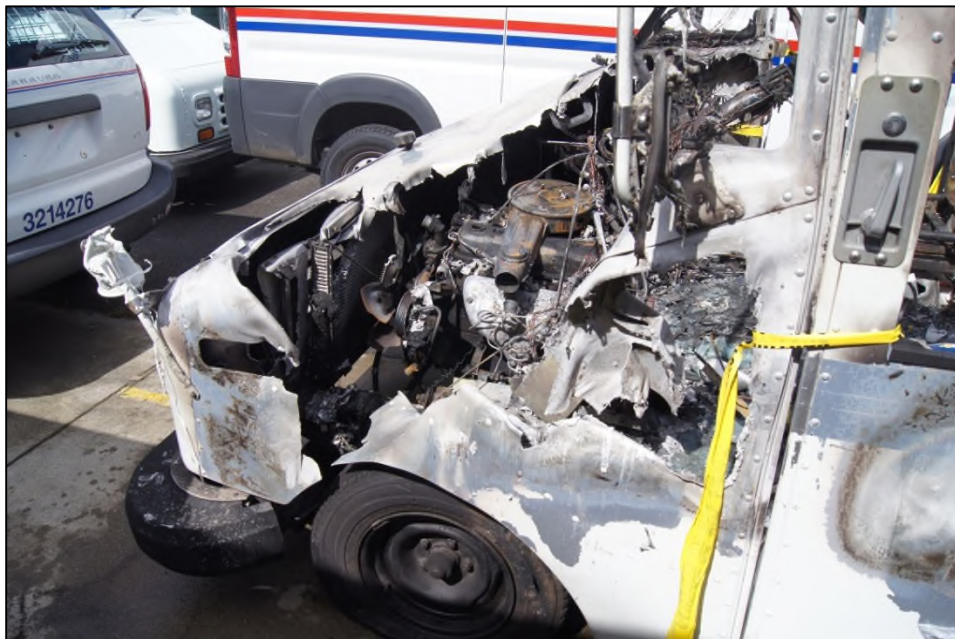
Photograph 2

Left front of LLV showing origin area.

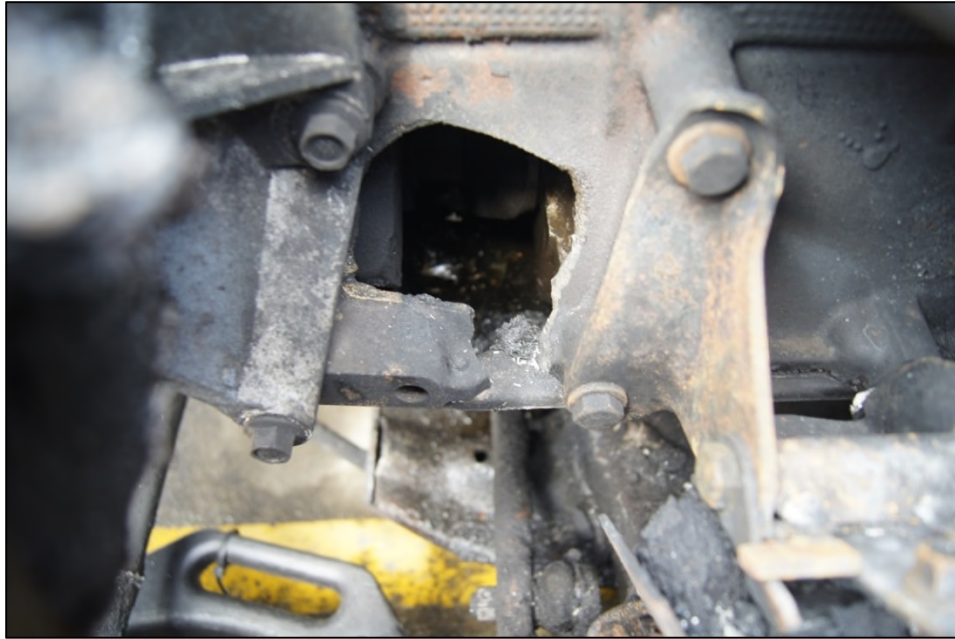
Photograph 3

Hole in engine block from connecting rod.

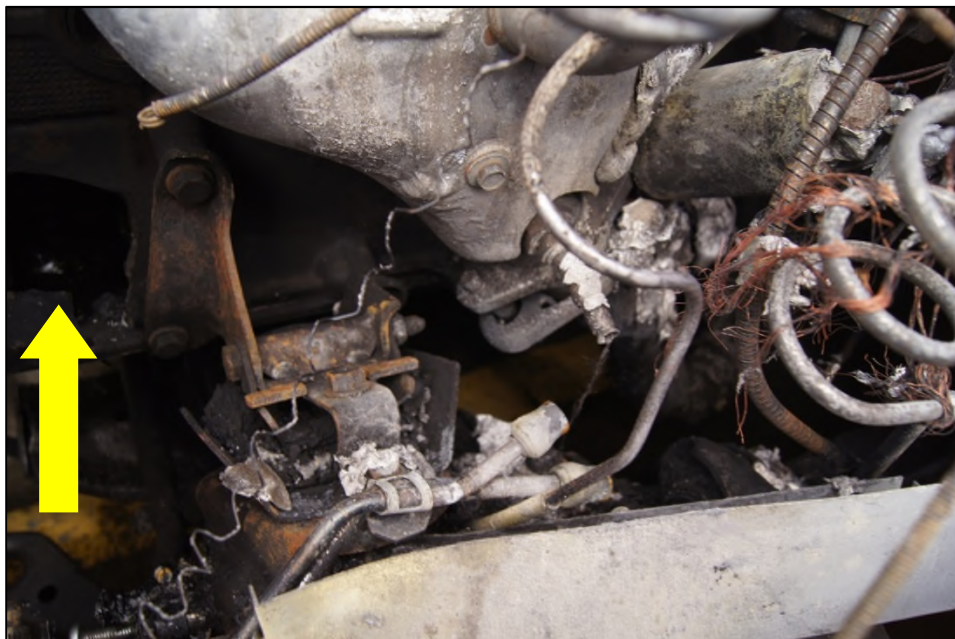
Photograph 4

Hole in block in close proximity of exhaust.

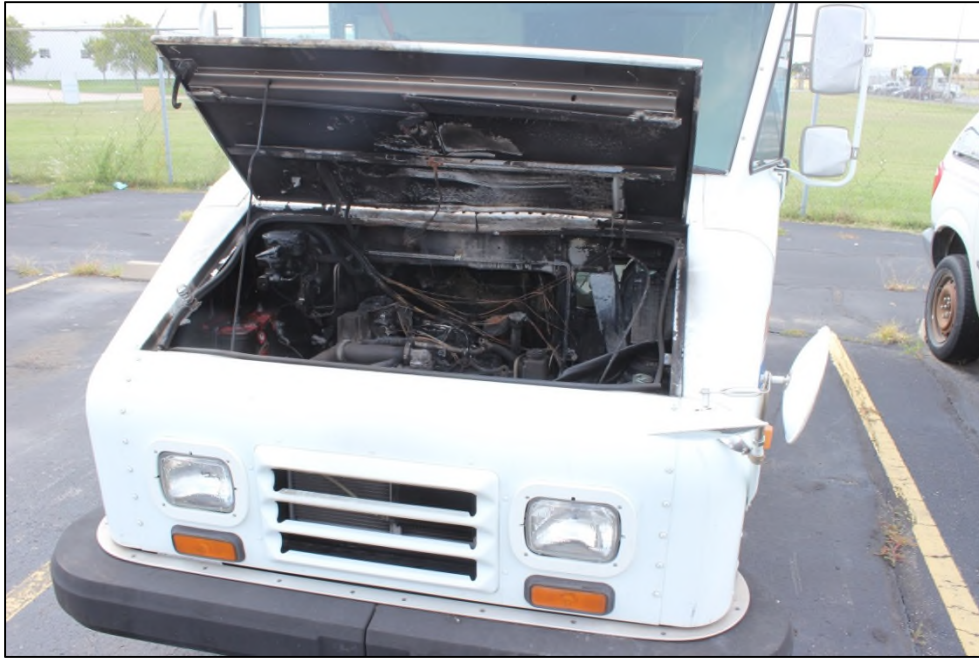
Photograph 7

View of the interior of the engine compartment.

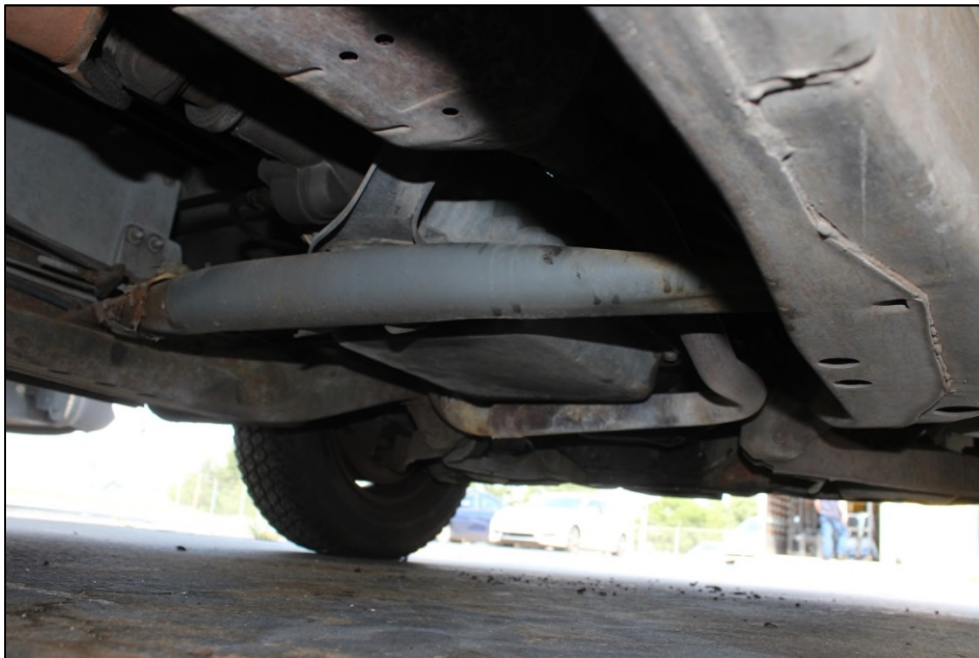
Photograph 8

View of the undercarriage of the vehicle.

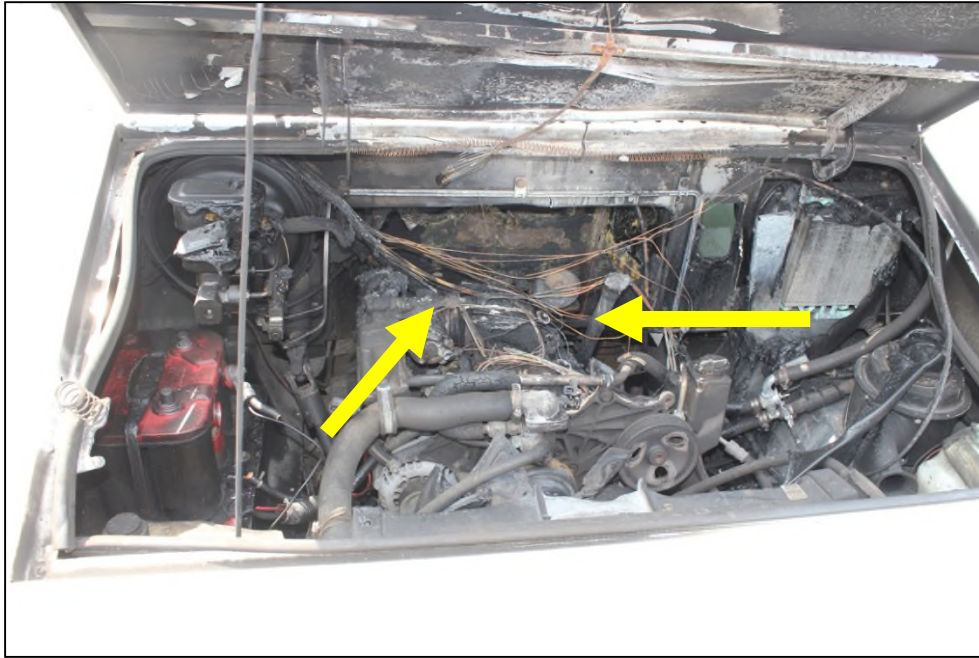
Photograph 9

View of the fire damage area of the engine compartment. View of area of origin.

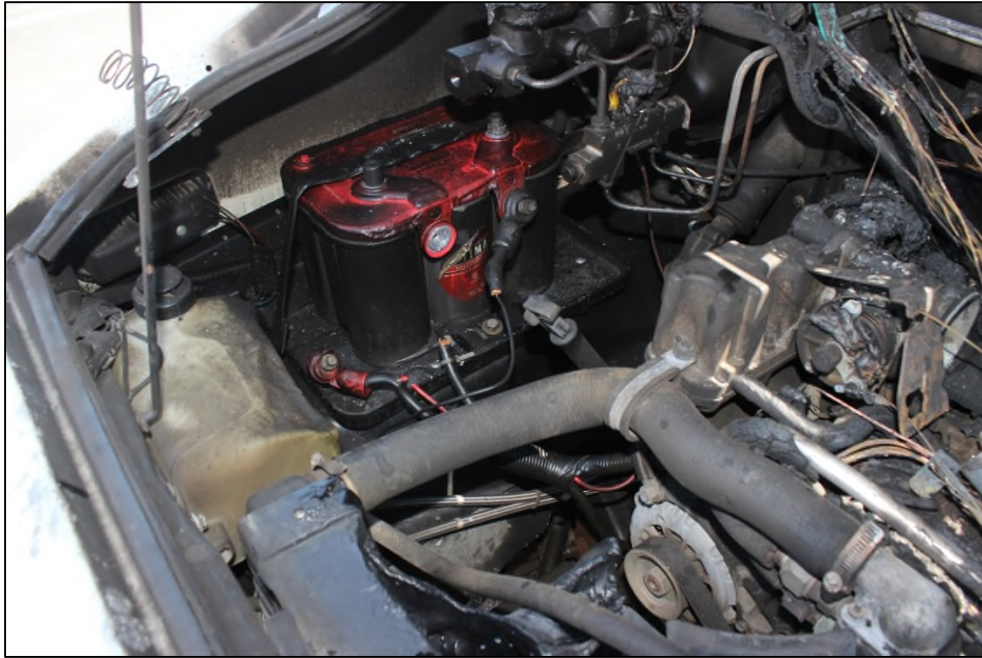
Photograph 11

View of the right side of the engine, with the fire and heat damage.

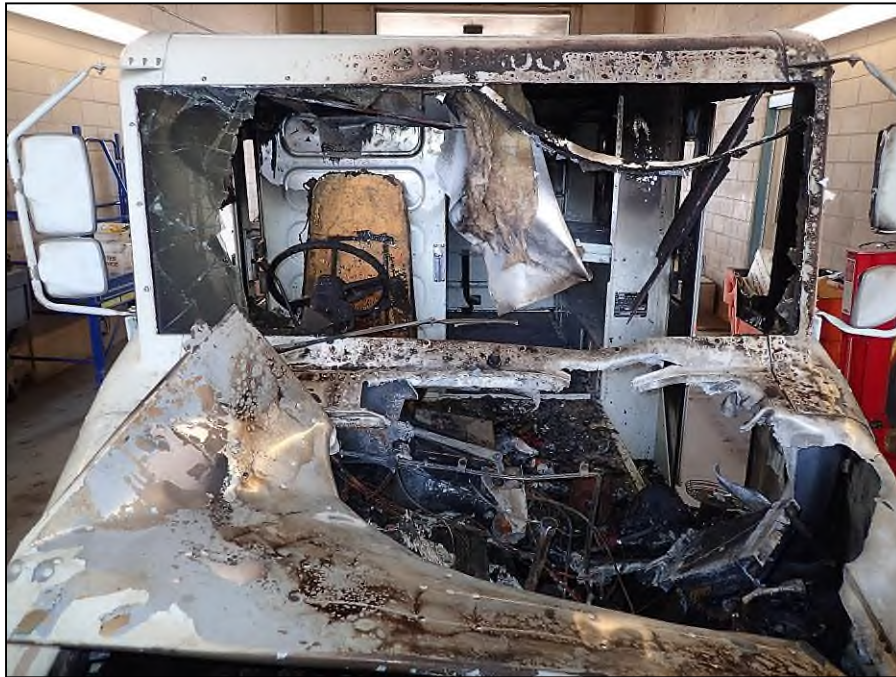
Photograph 7
Hood and windshield opening.

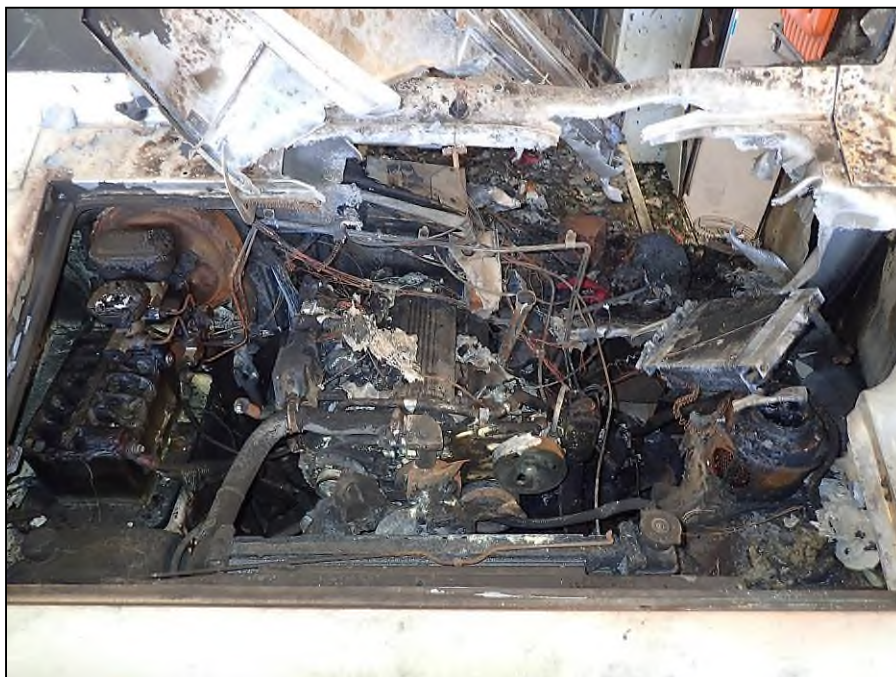
The engine compartment was examined. The 2.2 liter engine was manufactured by General Motors. Fire damage and mass loss was observed throughout the engine compartment. The most profound area of fire damage and mass loss was observed along the mail side of the engine compartment in proximity to the exhaust manifold and the bulkhead. Fire patterns communicated upward and outward from the left rear corner of the engine.

Photograph 8
View of the engine compartment.

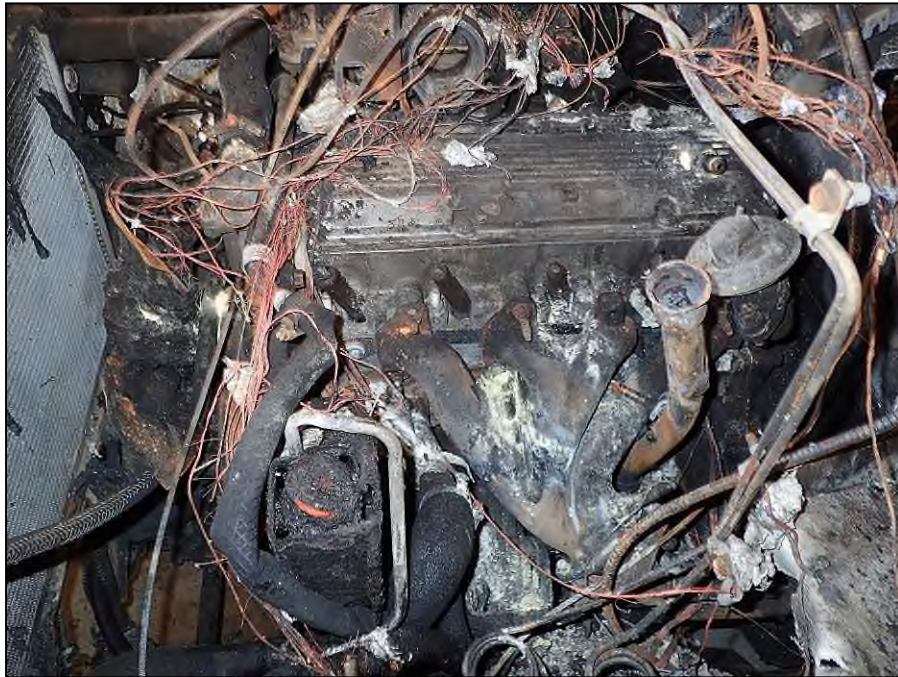
Photograph 9

As a result of the fire, numerous electrical conductors and harnesses were damaged throughout the engine compartment. Physical evidence of electrical activity was observed along several small conductors located in and along the left rear portion of the compartment. In our opinion, the observed physical evidence of electrical activity was the result of the fire communicating upward from the topside of the exhaust manifold and impinging on the listed conductors.

View of the area of fire origin.

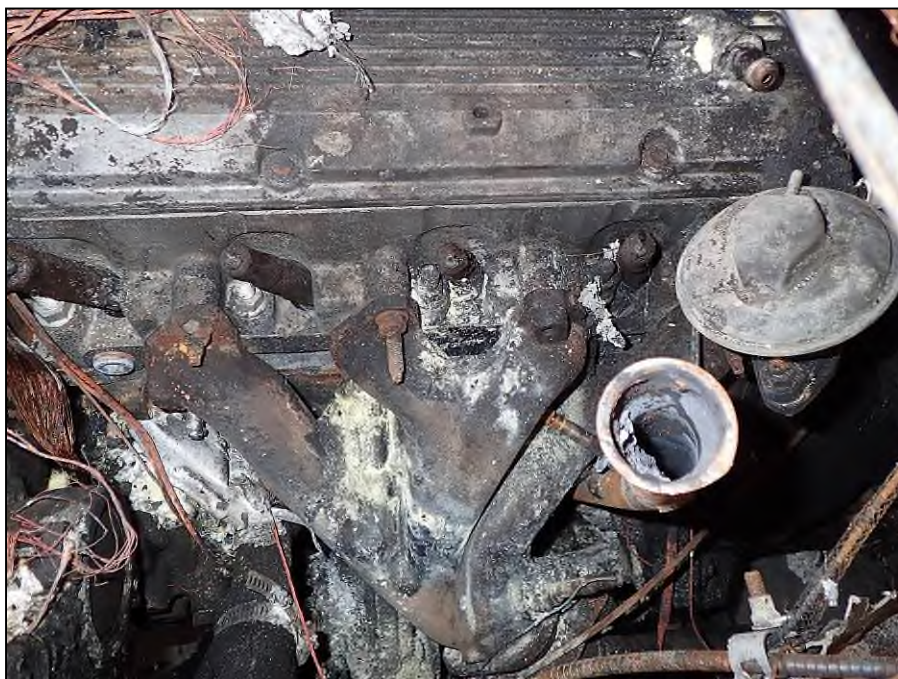
Photograph 10

A closer view of the area of fire origin. Fire extinguisher powder was observed along the top of the manifold.

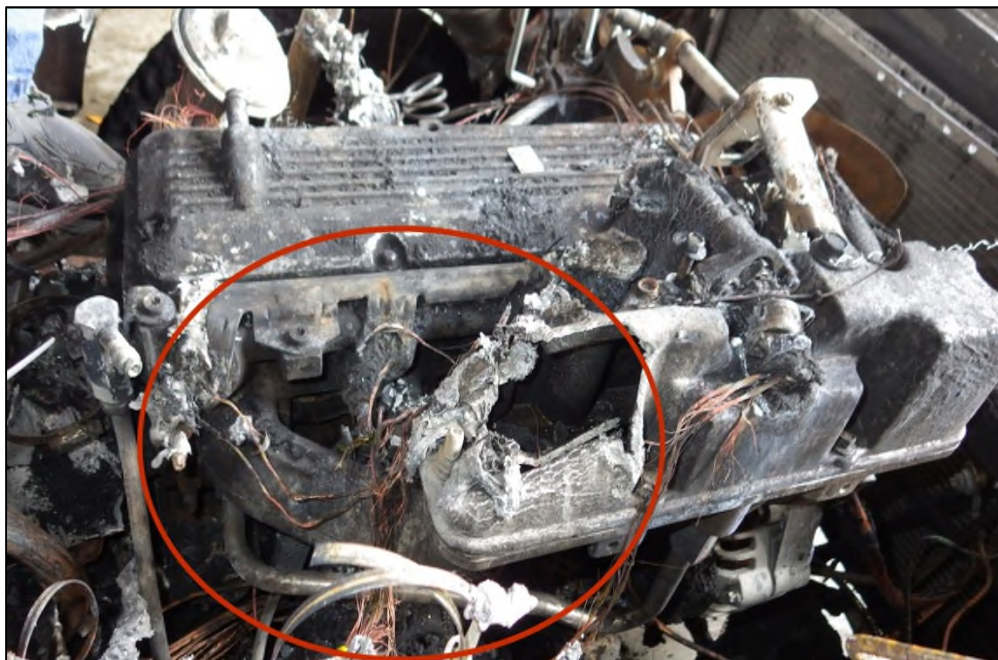
Photograph 4
Close view origin.

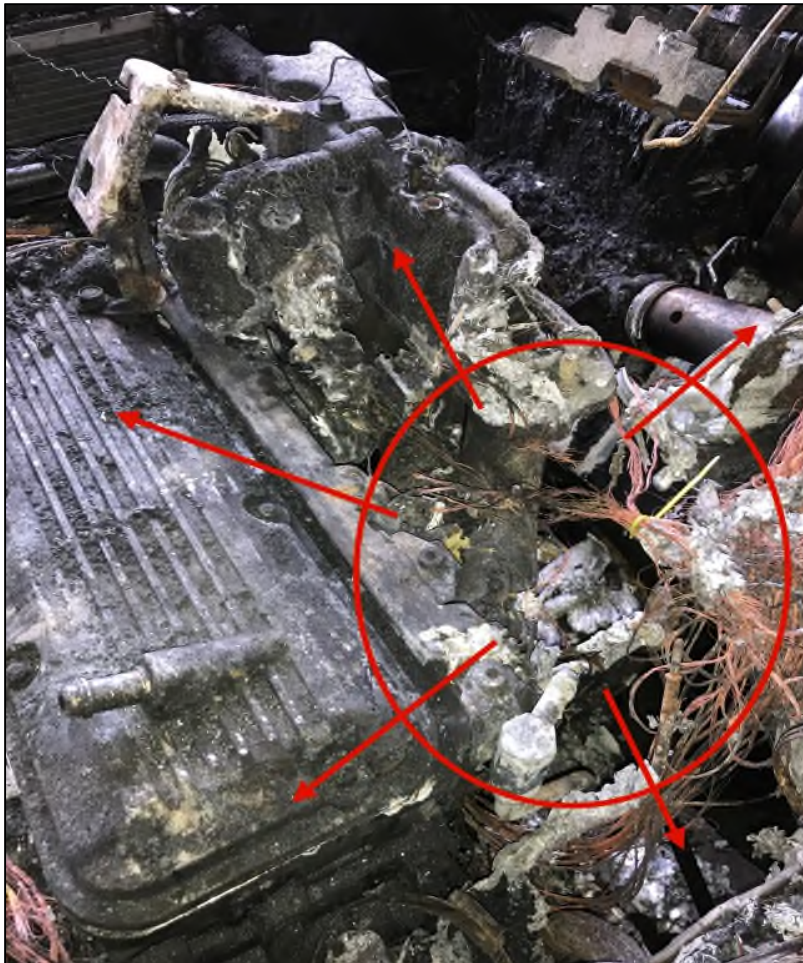
Photograph 5
Top view of origin.

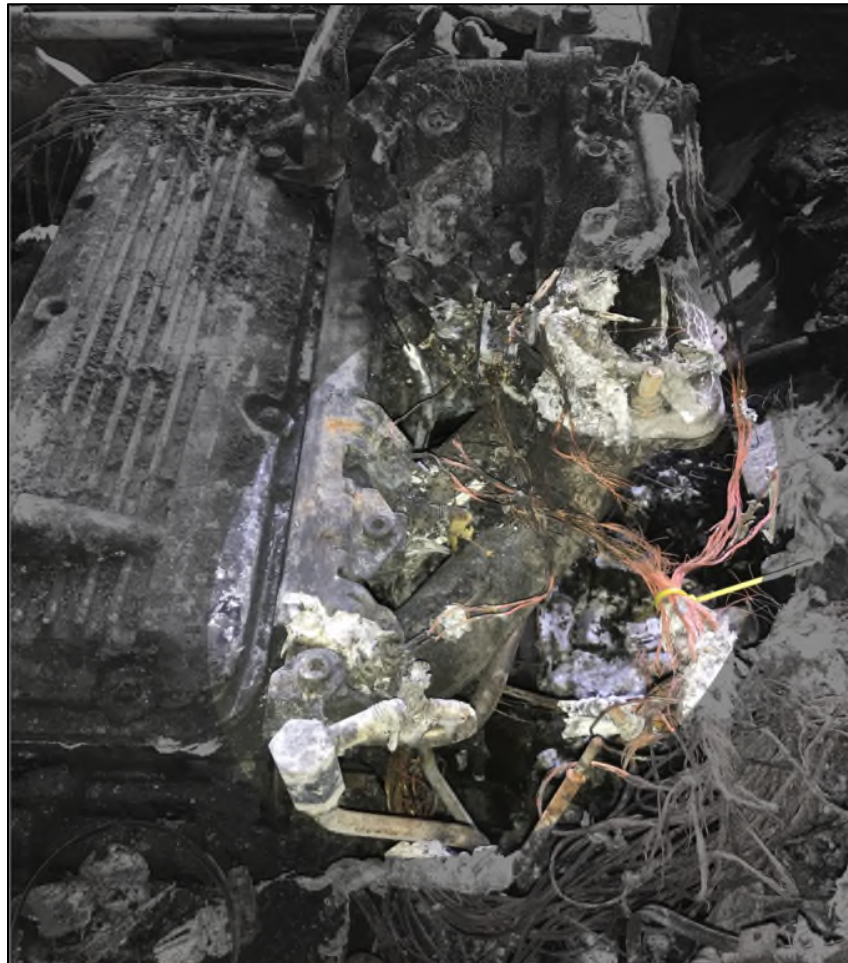
Photograph 6
Highlighted origin.

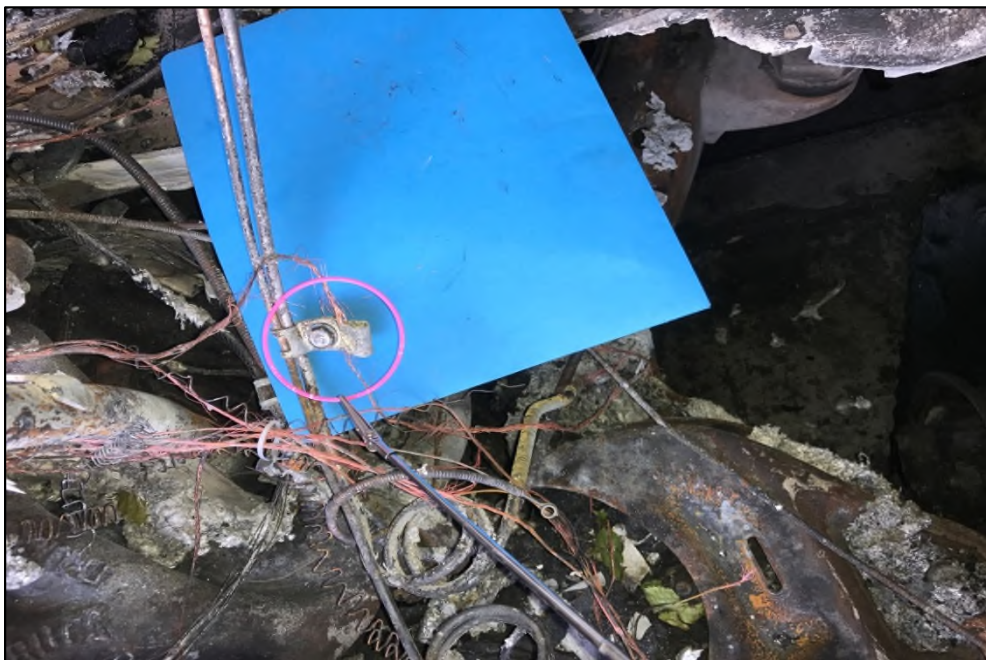
Photograph 8
Improper wire routing.

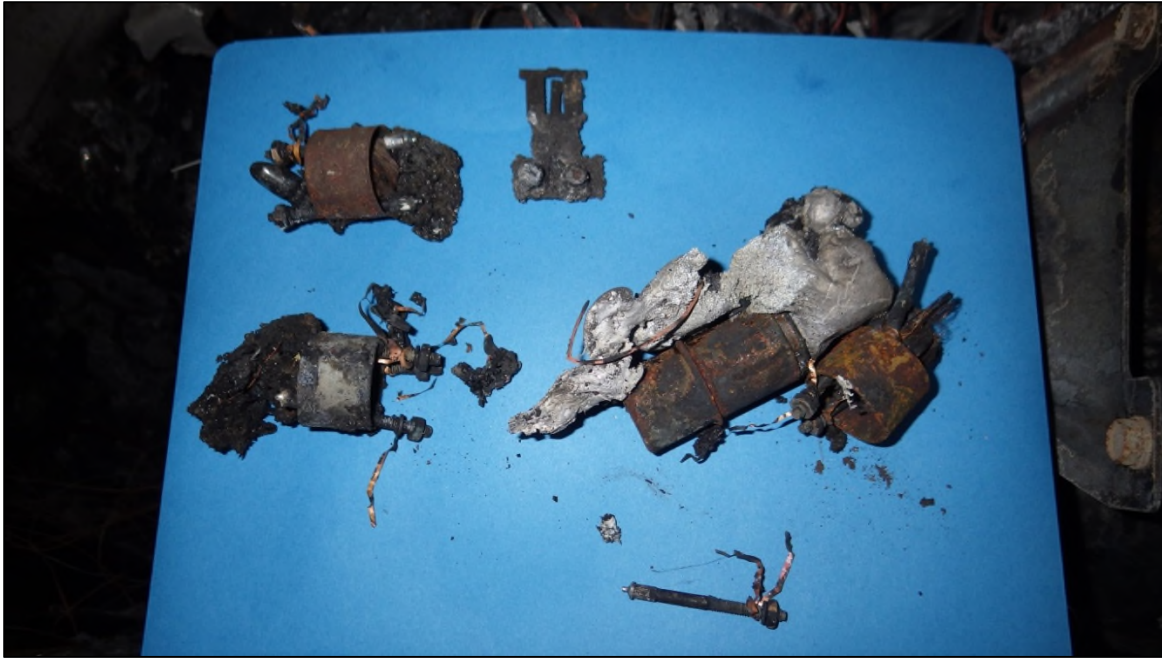
Photograph 9
Artifacts from area of origin.
